This memorandum summarizes a site survey performed July 5, 2018 to evaluate the condition of ADA mandated access at the Herring Run Park in Pembroke Massachusetts. After a description of the site and site uses, recommended improvements are provided in Section 7, beginning on page 3.

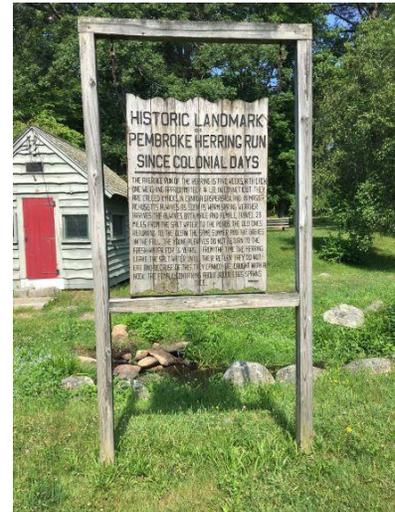
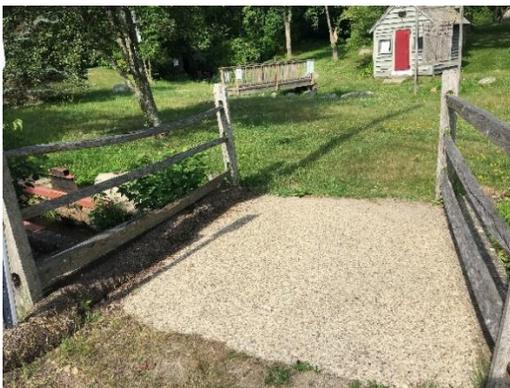
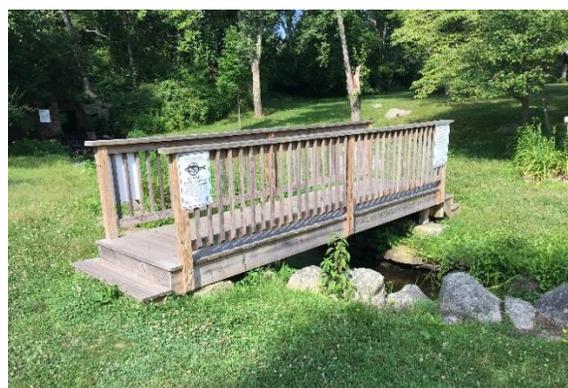
Herring Run Park contains two historical displays, several picnic tables, a grill, an old mill site and two fish ladders. These areas are set-in grass with scattered trees. There is a small open lawn area to the north of the parking with two granite benches and a historical structure. The remaining section of the park is on the other side of two brooks that eventually converge into one running from the southeast corner to north of the parking area. Access from the parking area to the larger side of the park requires pedestrians to cross two brooks. Passage over the first brook is provide by either a flush concrete bridge with wood rails or a wood deck bridge with two step ups on either side. Both bridges lead to the grassy median between the two brooks. Access over the second brook is provided by another wood deck bridge with two step ups on either side or a gravel path leading over the culvert in the southeast corner of the park.

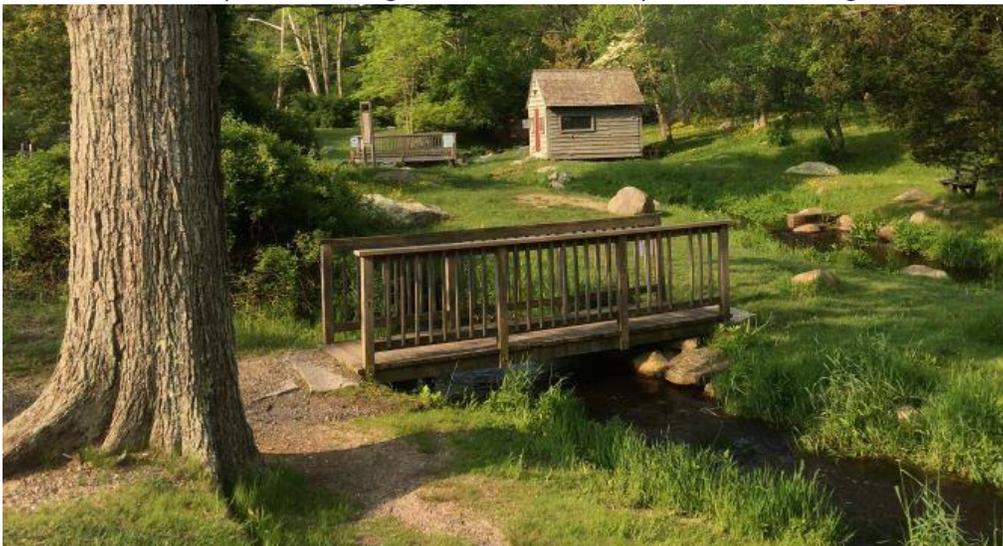
There are no outdoor recreation access routes (ORAR) with in the entire site. In order for there to be access to the picnic tables, grill and benches, they need to be along a ORAR.
